**FISH PASSAGE RESTORATION:
POST CONSTRUCTION MITIGATION
MONITORING REPORT
YEAR 5**

July 2008

Contract Number PG3445173

NORTHWEST BRANCH AND SLIGO CREEK

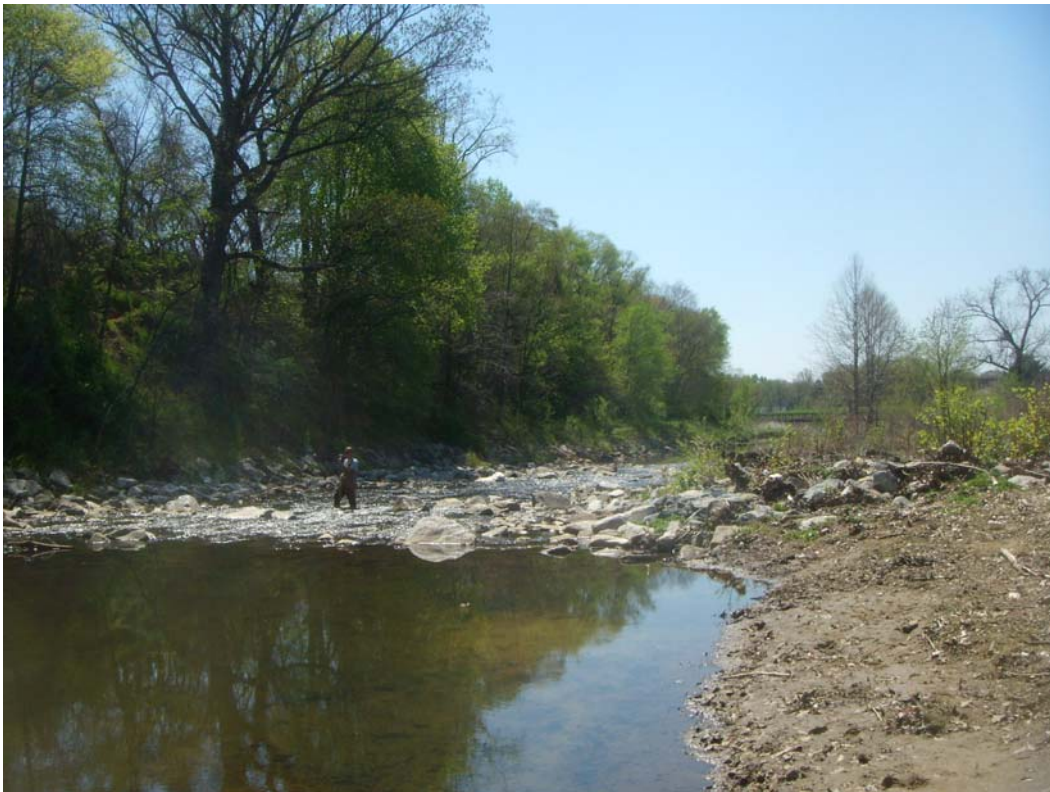
Northwest Branch – 2 looking downstream, April 2008

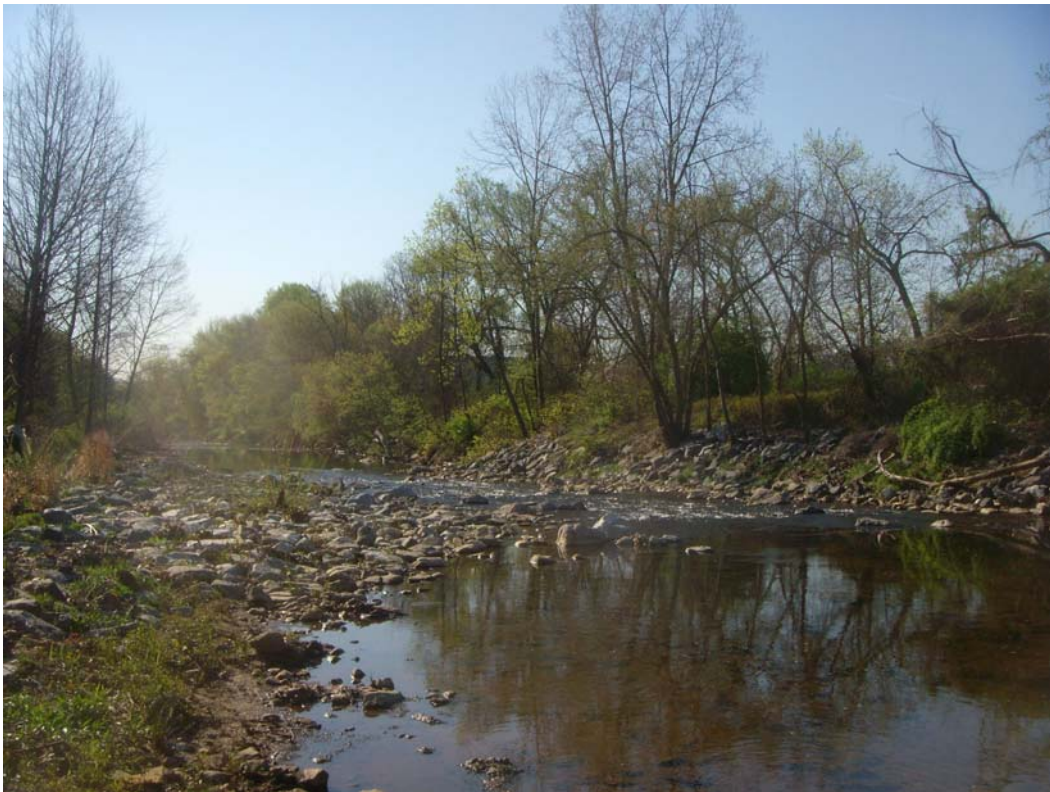
Northwest Branch– 4 looking downstream, April 2008

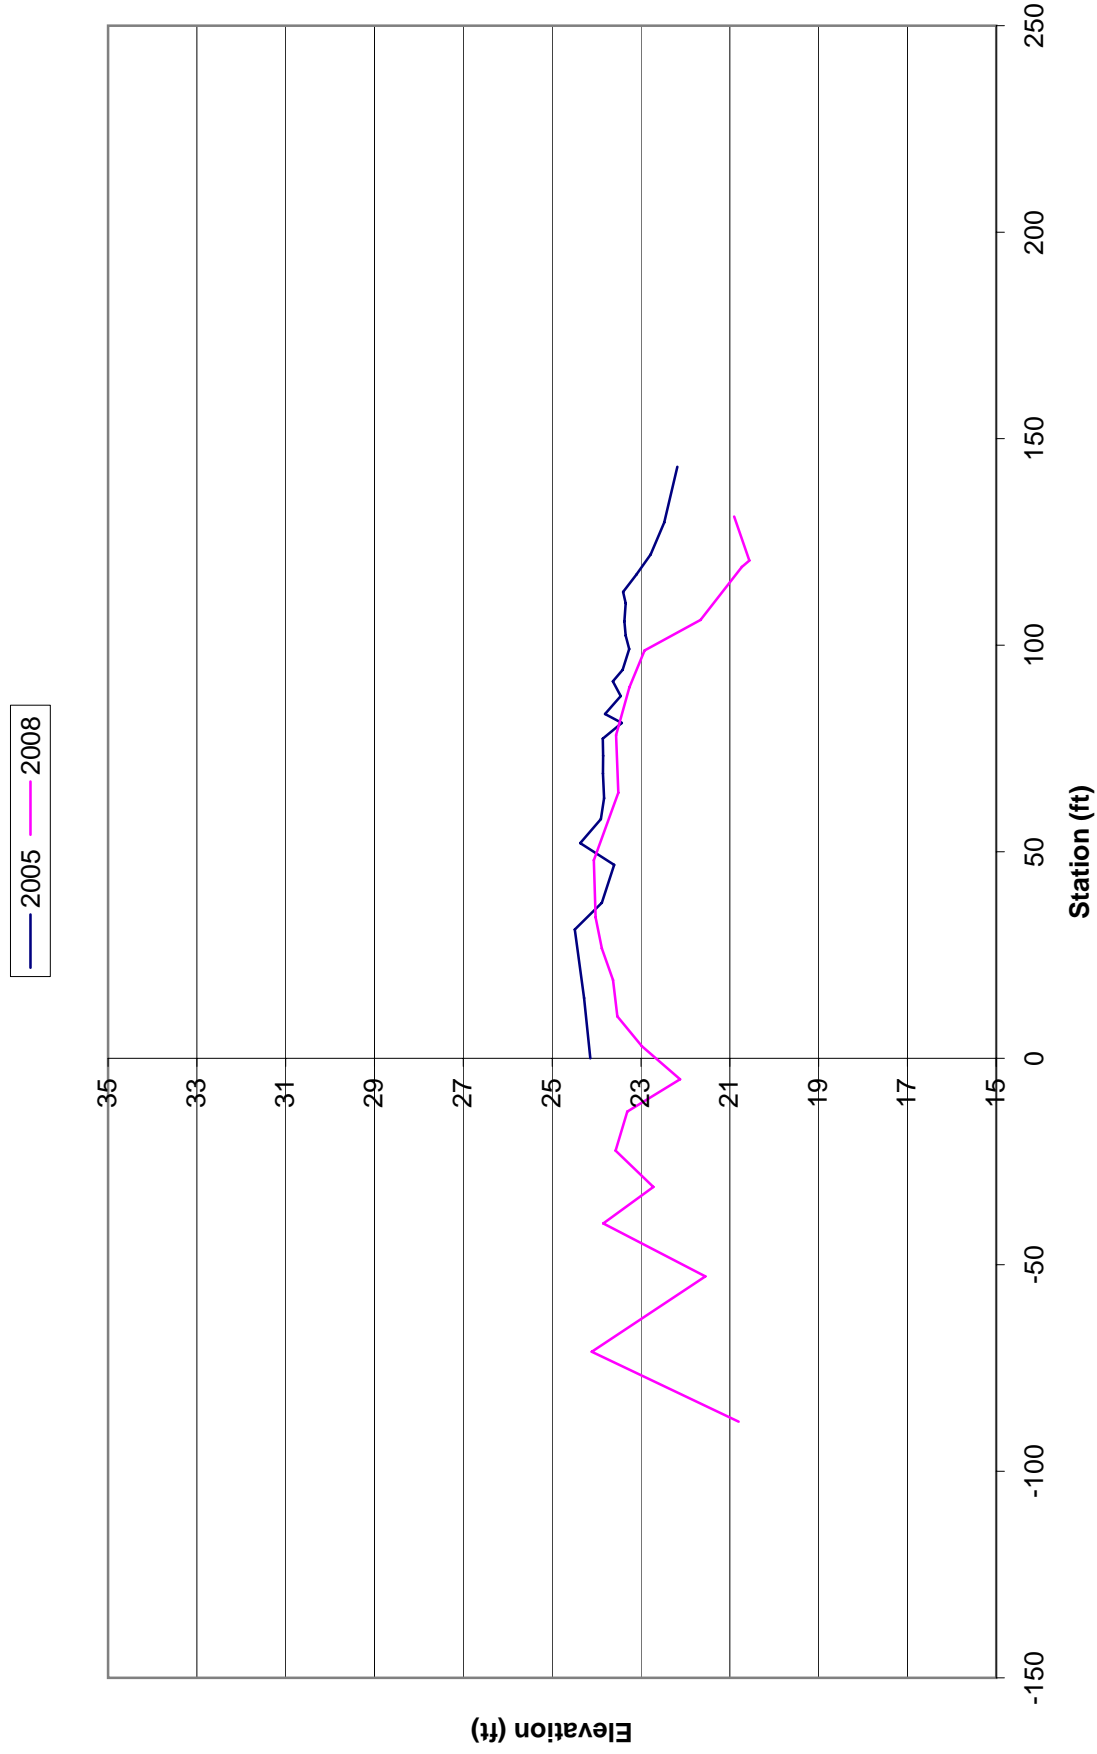
NW-5 Longitudinal Profile 2005 and 2008

The scour towards the bottom of the structure has also caused a significant break in the grade of the stream. This break in grade (nick point) has migrated upstream about eight feet. There is an associated break in water surface elevations at this nick point but it does not appear significant enough to cause any kind of fish blockage. Continued loss of grade through the RGC will cause a more significant break in water surface elevations. The crest of the structure appears a bit lower than the as built survey, but it is still controlling grade in the stream and creating a head pond. The nick point in NW-5 should continue to be monitored to see if it will migrate upstream. NW-5 will be resurveyed in the Spring of 2009. Visual assessment field forms are available in *Appendix E*.
