**FISH PASSAGE RESTORATION:
POST CONSTRUCTION MITIGATION
MONITORING REPORT
YEAR 5**

July 2008

Contract Number PG3445173

NORTHWEST BRANCH AND SLIGO CREEK

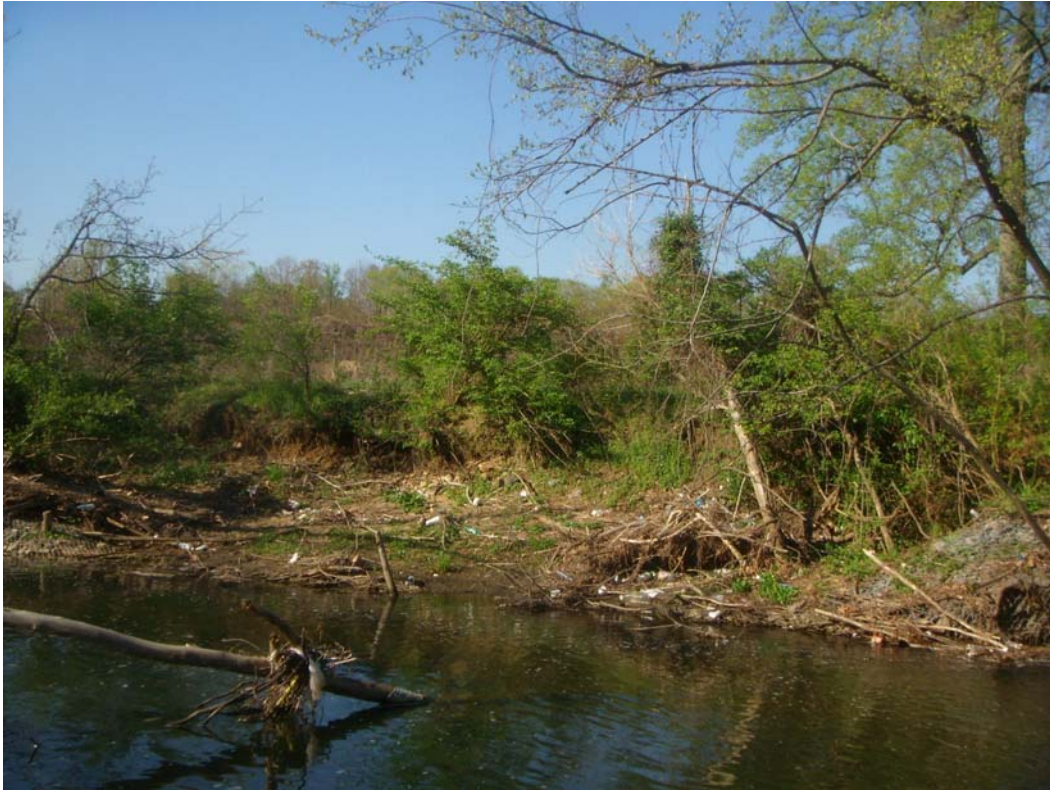
The monitoring data shows that the majority of the sites have remained stable, exhibiting no discernable loss of integrity. However, NW-5 continues to have structural issues, and the notch in the sheet pile weir at SC-1 is frequently clogged with debris. A full survey of NW-5 was conducted again this year because of structural issues identified in the visual assessment. Concerns about NW-5 from the 2007 report included exposed gas lines in the channel, dislodged concrete mattresses which previously covered the gas lines, and a failure of the right gabion wall downstream of the structure. Within the past year, a nick point developed at the bottom of the structure and migrated upstream about eight feet. Visual observations of the right bank indicate that the failed gabion wall has moved downstream slightly. The bank behind the gabion wall appears stable. Neither the nick point or failed gabion wall are acting as blockages to fish migration; however, they require continued attention.

Northwest Branch – 5 Collapsed gabion and bank, April 2008

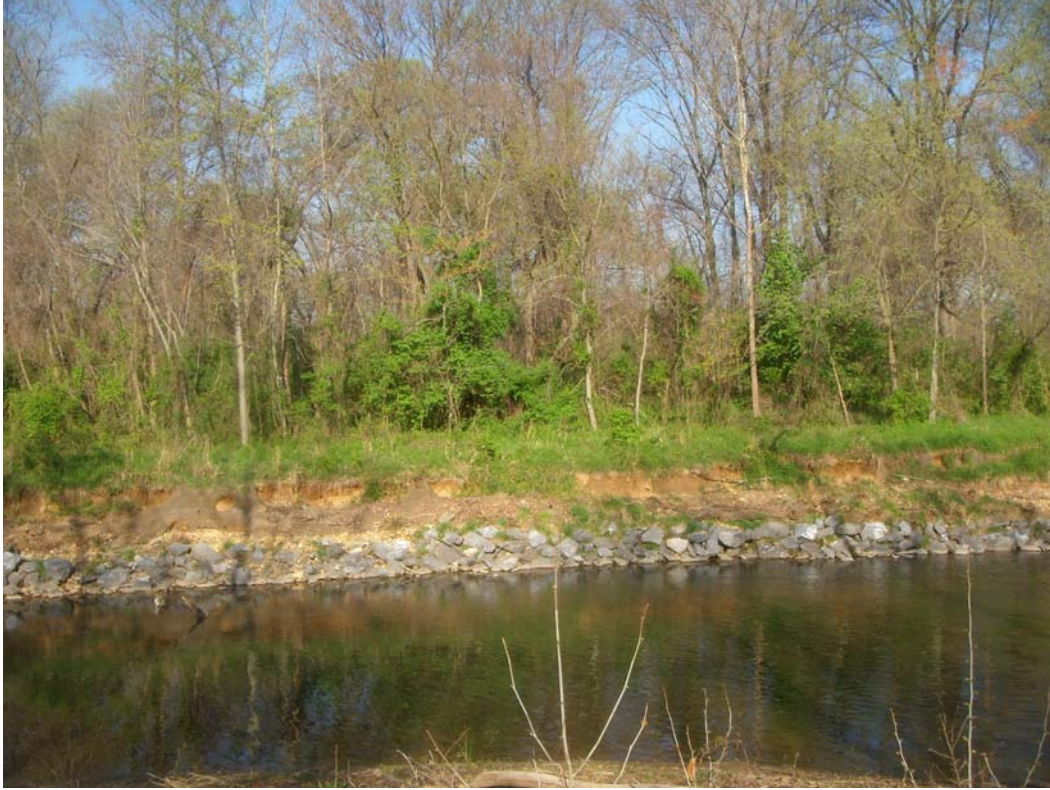
Northwest Branch – 6, erosion on right bank, April 2008
