**FISH PASSAGE RESTORATION:
POST CONSTRUCTION MITIGATION
MONITORING REPORT
YEAR 5**

July 2008

Contract Number PG3445173

NORTHWEST BRANCH AND SLIGO CREEK

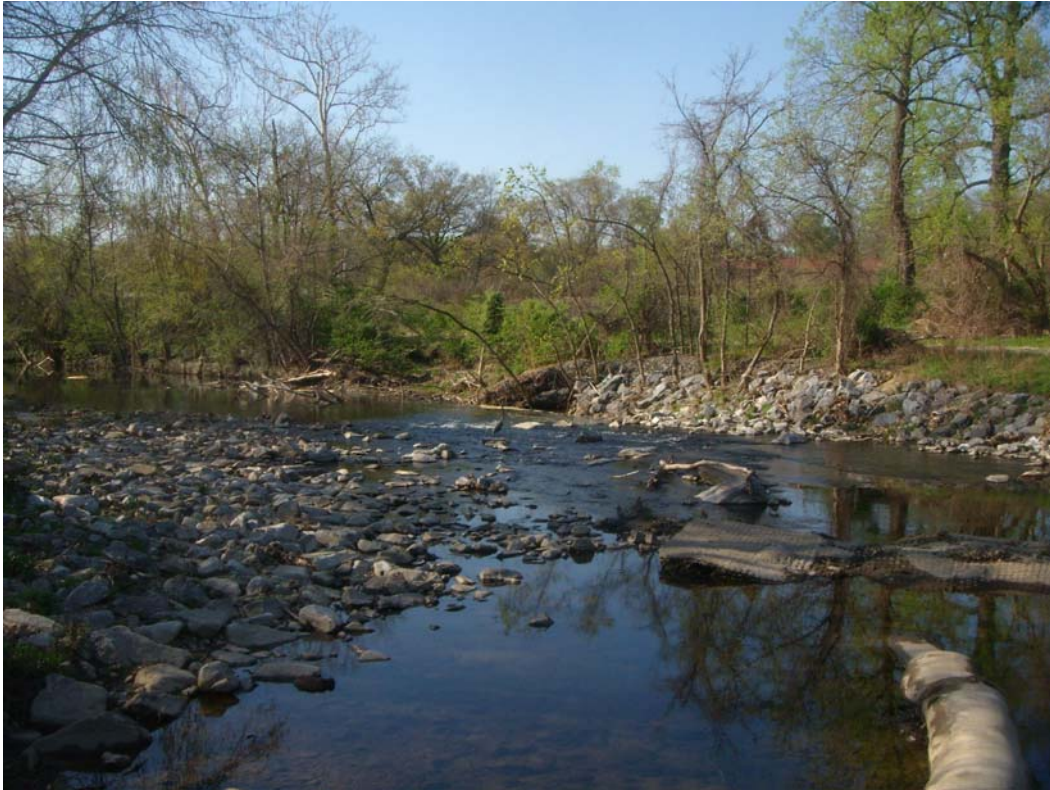
Northwest Branch– 5 looking downstream, April 2008
